**Re: Missouri Electric Works Facility
Trip Report
EPA Work Assignment No. 43-7W6R
Jacobs Project No. 10-D243-01**

**ALTERNATIVE REMEDIAL
CONTRACTS STRATEGY
REGIONS VI, VII & VIII**

**TRIP REPORT
FOR
JANUARY 28, 1991 TO MARCH 1, 1991
MISSOURI ELECTRIC WORKS FACILITY
CAPE GIRARDEAU, MISSOURI**

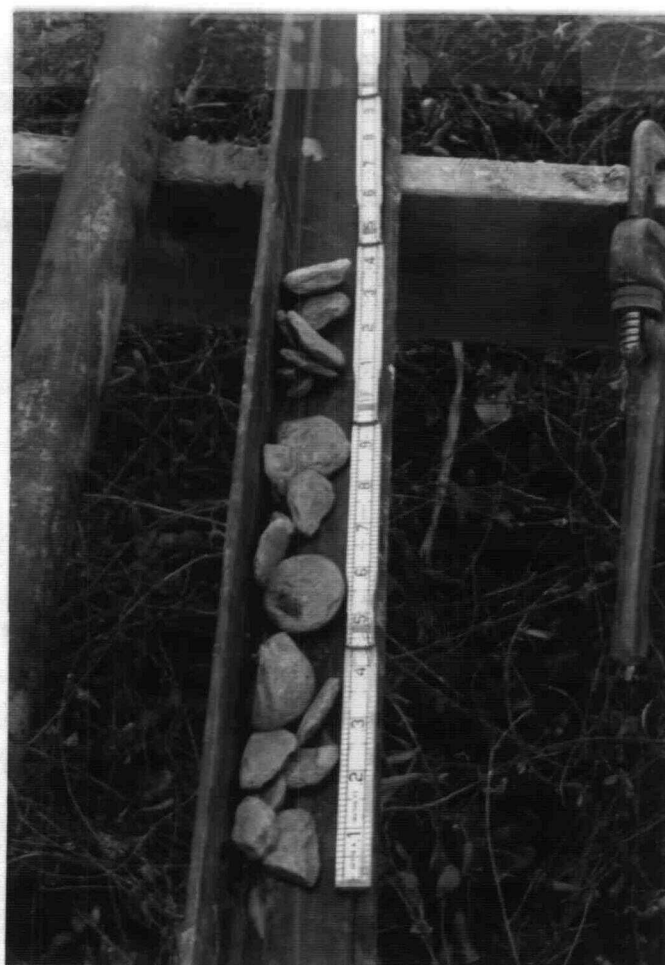
PHOTOGRAPH NO. 3

Drilling operations resumed at 1112 by punching through the grout plug at the bottom of the borehole. Air coring through the competent limestone/bedrock commenced at 1400. At 1545 a rock core from 61 to 64 feet was recovered. The rock core was thinly bedded/fractured limestone which constitutes the weathered/fractured bedrock zone (Photograph 3). The same weathered/fractured bedrock zone was present

Subject: Core from 61 to 64 feet.

1454 Photobk Roll #1
ASA100 NW
Core from 61-~~63~~⁶⁴'. Broken fragments were recovered. Jim Fels of MDNR, a state geologist states that is might be the Blatton limestone, Ordovician in age. That is what the geologic map states. Sample is brownish-gray. Sample is broken up probably due to the surface being weathered or highly fractured. Also is probably thinly bedded. - Sample shows fractures, possibly filled with calcite.

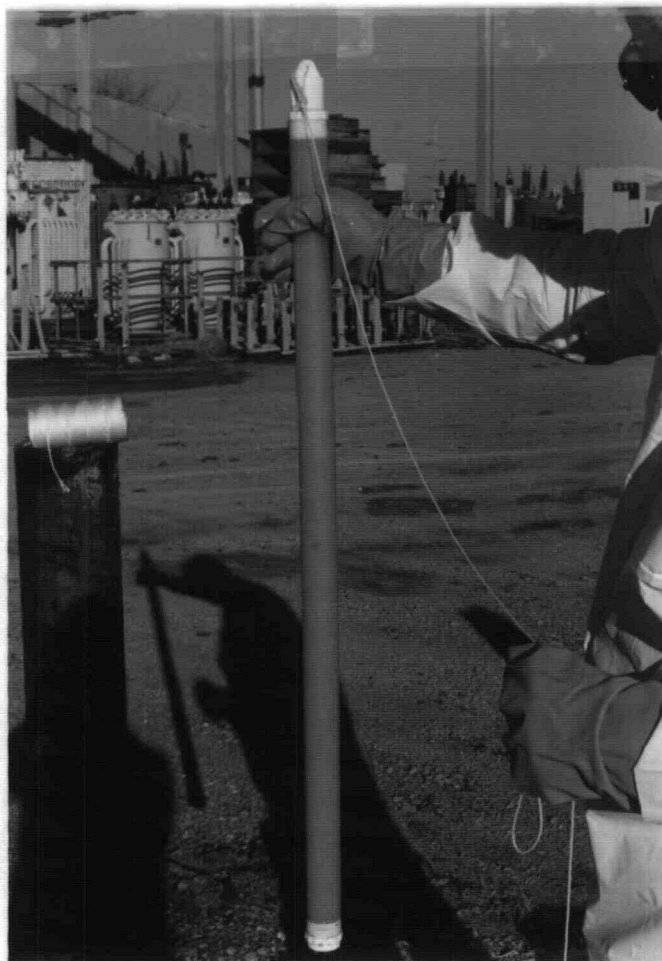
PHOTOGRAPH NO. 4

TETC personnel resumed purging of RI monitoring wells and continued measuring water quality field parameters. The purged water was highly turbid in most monitoring wells. Photograph 4 shows purge water from MW-10. All groundwater quality field parameters are listed in Table 2 along with the appropriate purge volumes. Samples were collected once purging was completed from the shallow RI monitoring wells at 1737. Mathes personnel began lowering 4-inch I.D. casing inside the already set 6-inch I.D. casing. Mr. Trometer left the site at 1805. New personnel onsite included:

Subject: Purge water from MW-10.

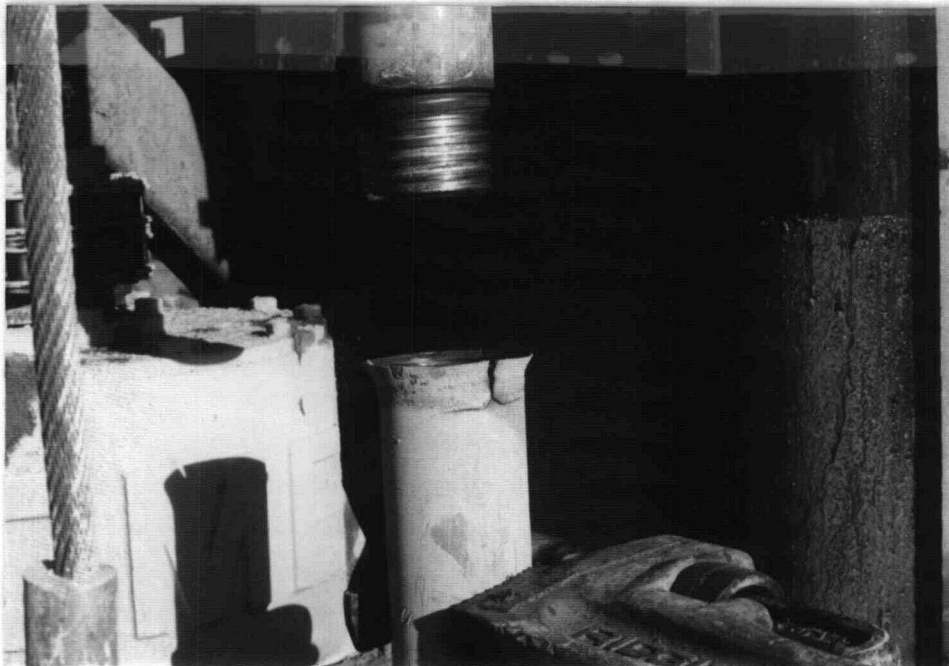
PHOTOGRAPH NO. 5

At 0830 Kent Schaffer of Mathes arrived onsite with a new air compressor. The air compressor was a Schramm 350 psi/850 cfm unit. Mathes personnel once again had problems with breaking the coupling connected to the drill rods (Photograph 5). At 1545, the drillers tripped out of the borehole after cracking 3 couplings. At 1610 a core sample from 69 to 74 feet was collected (Photograph 6). The sample showed intermittent iron oxide staining, and fractures filled with calcite (Photograph 7). TETC personnel measured the water level in the borehole. The water level was recorded at 60.65 feet from the top of casing (with a 3-foot stick-up).

Subject: Split coupling.

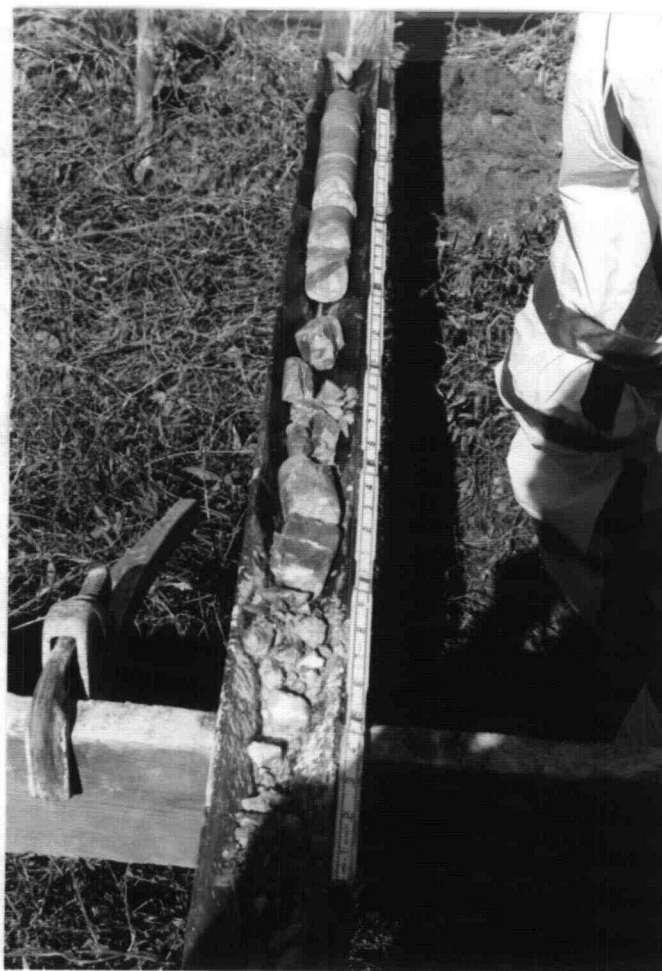
PHOTOGRAPH NO. 6

Subject: Core from 69 to 74 feet.

1103 Photo 9 Roll # 3
ASA200 N
Picture of core from 69-74' ~~betting~~ pretty good recovery now. Sample is limestone/Dolomite, fine-grained with fractures & Festoons, color is brown-gray. Some of the fractures are filled in. Core sample is being handled with surgical gloves.

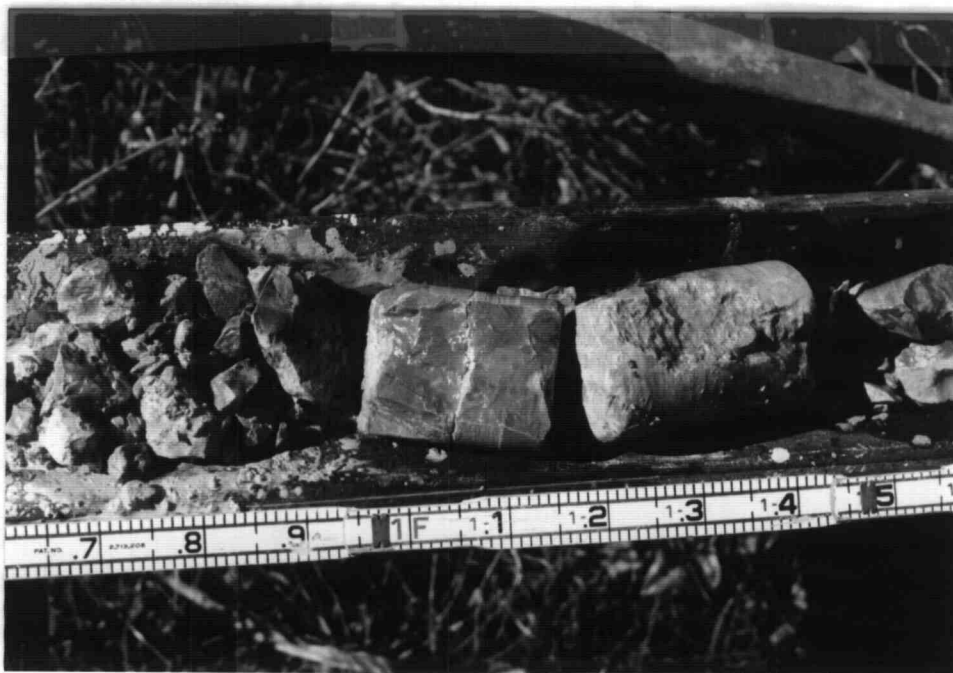
PHOTOGRAPH NO. 7

Subject:	Core sample from 69 to 74 feet (note fractures and staining).		
Location:	Southeast of drill rig.		
Date:	2/02/91	Time:	1103
Photographer:	Todd Trometer	File No.:	N/A
Film:	ASA 200	Witness:	N/A
Direction of Photograph:	North

1103 Photo 8 Roll # 3
ASA200 N
Picture of staining on core sample

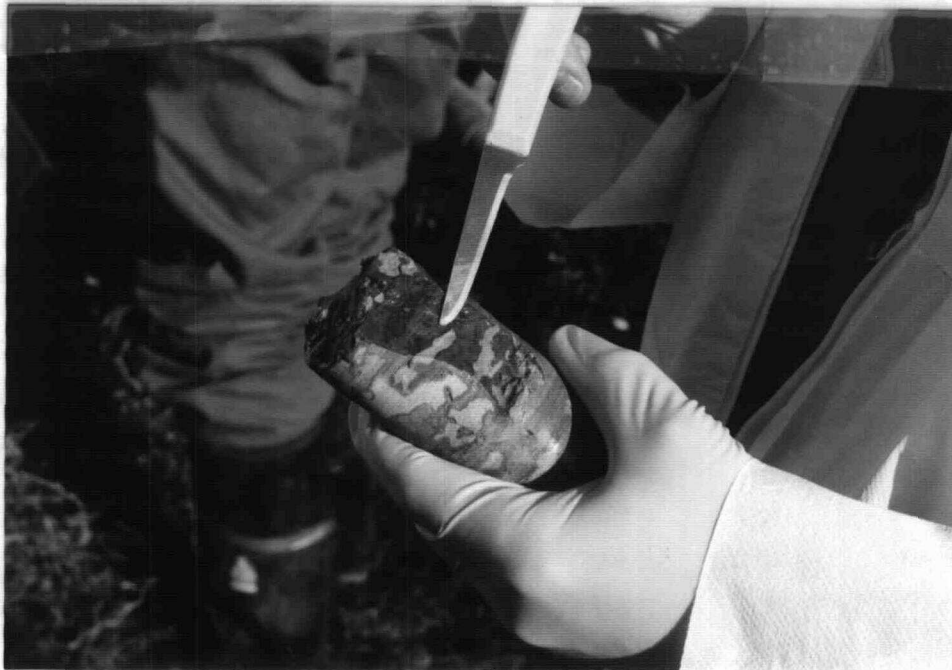
PHOTOGRAPH NO. 9

Upon sampling completion, Mathes personnel once again resumed air coring, this time by adding water to the borehole. At 81.5 feet to 82.5 feet, one foot of void space was encountered, which was probably a mud seam. This conclusion was based on the abundant mud cavities found in the core (Photograph 9).

Subject: Picture of mud cavities in limestone.

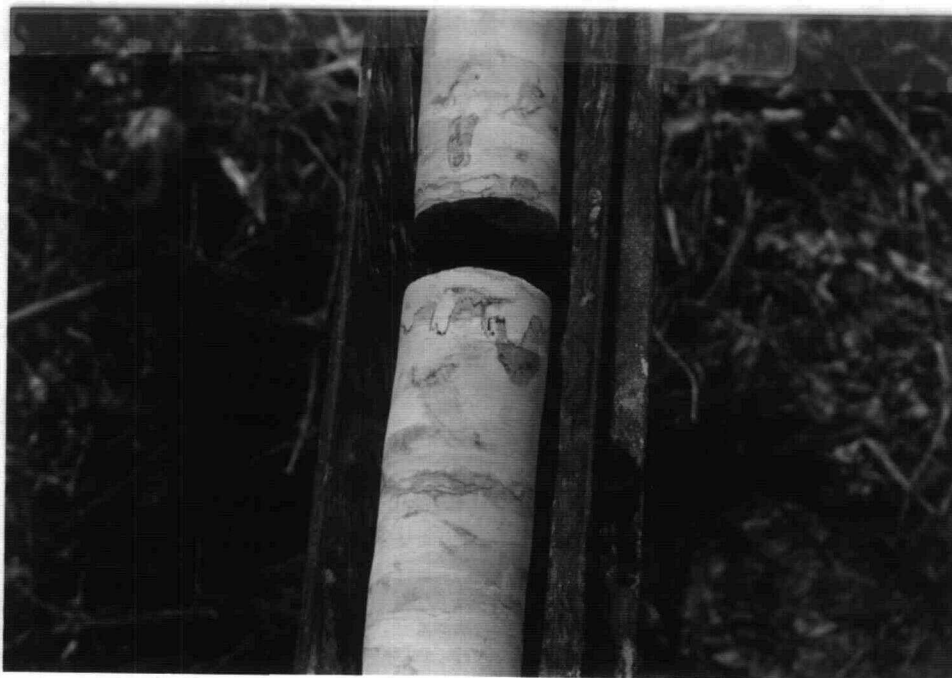
PHOTOGRAPH NO. 10

At 1228 the drillers pulled out a core sample from 82.5 to 87 feet (Photograph 10). This core sample contained abundant fracturing and an apparent stylolite feature. At 1740 Mr. Trometer left the site. New personnel included:

Subject: Picture of core from 82 to 87 feet.

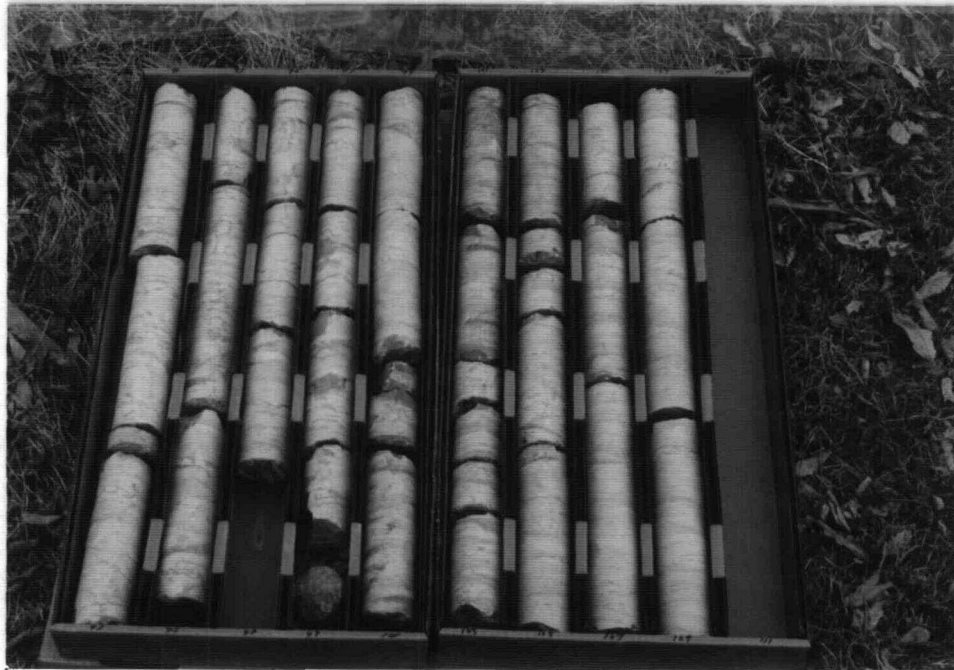
PHOTOGRAPH NO. 11

Subject: Core samples from 91 to 109 feet.
